Manhole Inspection Summary

Manhole # S35UU1006MH

Location Address: **324 WOODBOURNE AVE** Cross Street: **WILLOWMERE WAY**

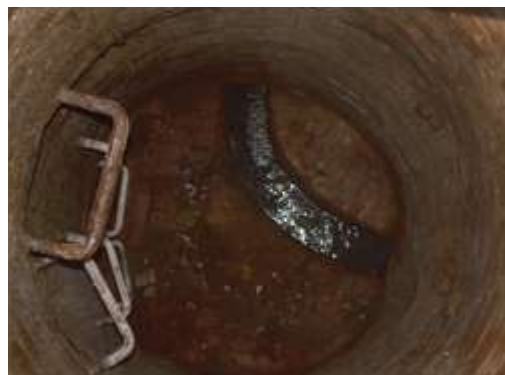
Top View

Steps Count: **6** Missing: **0** ☒ **Corroded**

Surcharge ☒ **Evidence Of Surcharge** Depth: **1** (ft.) ☐ Active Surcharge Present

Corroded steps. Evidence of surcharge - Bench debris. Channel debris.

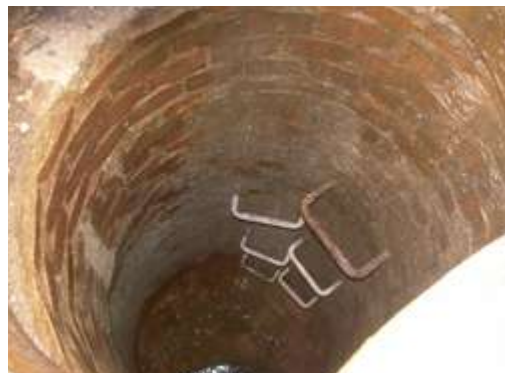
Defect

Adjustment, Corbel and Barrel infiltration.

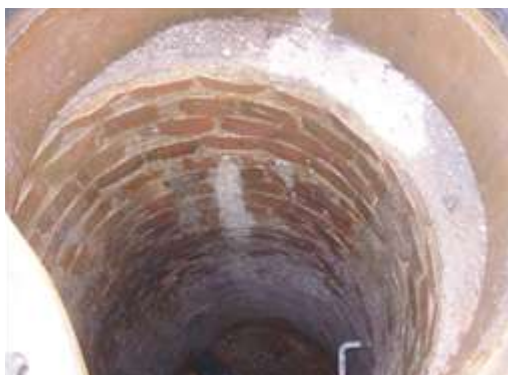
Defect

Frame Offset: **5** (in.) Condition: ☐ Sound ☐ Cracked ☒ **Leaks**

Chimney / Frame Adjustment ☒ Exists Material: **Brick** ☐ Parged Height: **32** (in.)
Condition: ☐ Sound ☐ Cracked ☒ **Root Intrusion** ☐ Loose Brick ☐ Deteriorated
Infiltration: ☐ None ☒ **Joint** ☐ Cracks ☐ Mortar ☒ **Roots** ☒ **Wall**

Frame leaks. Frame offset. Adjustment root intrusion and infiltration. Corbel and Barrel infiltration.

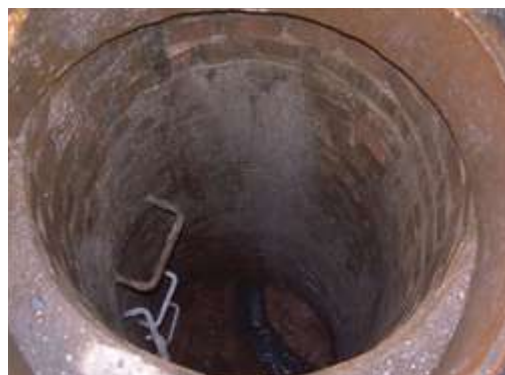
Defect

Frame offset. Frame leaks. Adjustment root intrusion and infiltration. Corbel and Barrel infiltration - other side.

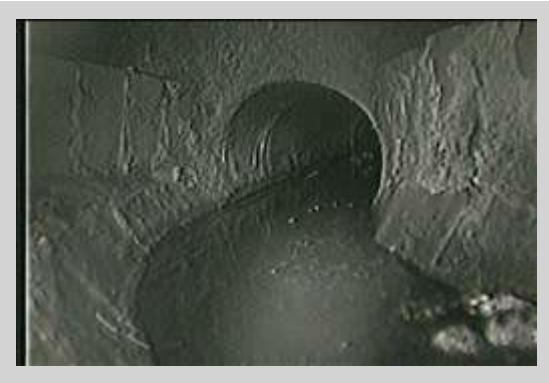
8 in. Circular Gravity Sewer Pipe Out @ 12 O'Clock

Deposits: ☐ None ☒ **Mud** ☐ Sludge ☒ **Debris** ☐ Grease

Silt Depth: **0.5** (in.) Deposits Extent: **Light**

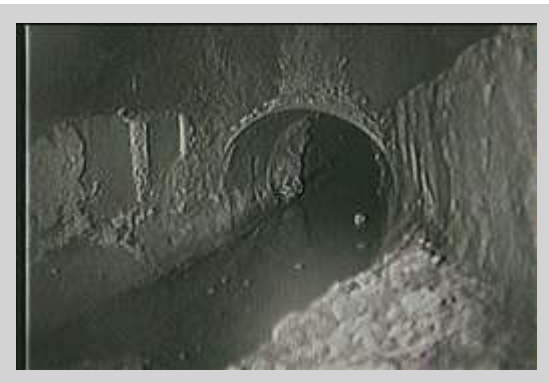
8 in. Circular Gravity Sewer Pipe In @ 4 O'Clock

Deposits: ☐ None ☒ **Mud** ☐ Sludge ☒ **Debris** ☒ **Grease**

Silt Depth: **0.5** (in.) Deposits Extent: **Light**
